Tarpon Harbor at Myakka Pointe Condominium Association, Inc.

Port Charlotte, FL • September 15, 2022

FULL RESERVE STUDY

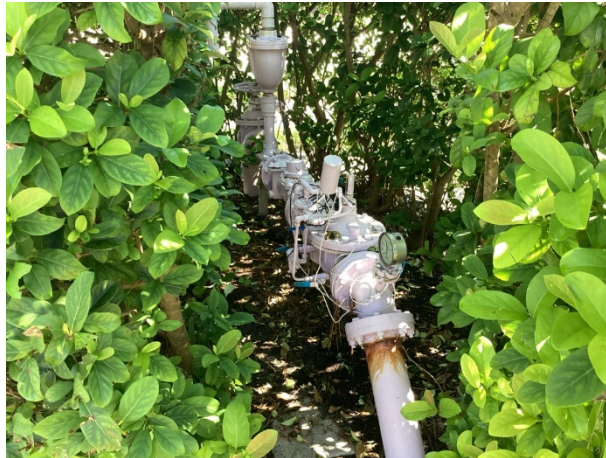
Water main shutoff valve

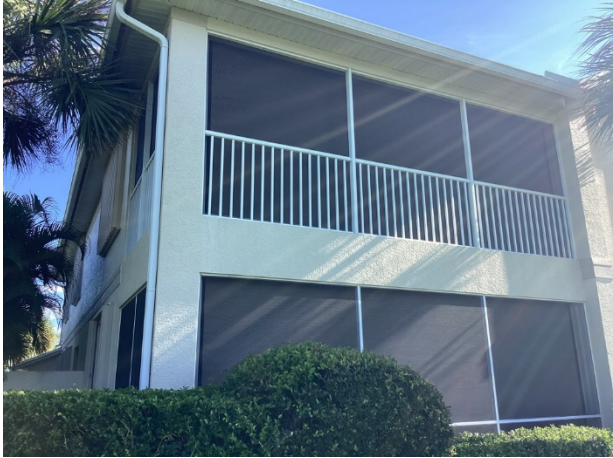
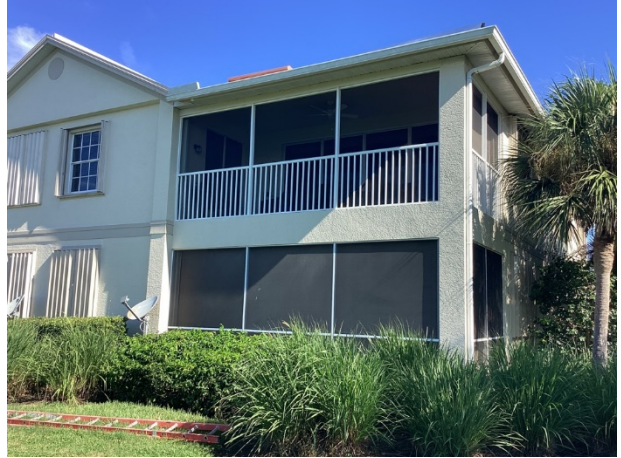
Condition: Good to fair overall with no significant deterioration evident from our visual inspection from the ground.

Balcony overview

Useful Life: Capital repairs including a close-up visual inspection, patching of delaminated concrete, routing and filling of cracked concrete, and waterproof coating applications every up to 25 years.

- Partial depth replacement of up to one percent (1%) of the concrete topsides, edges and undersides
- Crack repairs as necessary
- Removal of tile floor coverings
- Replacement of perimeter sealants as needed
- Application of a waterproof coating (Urethane based elastomeric)

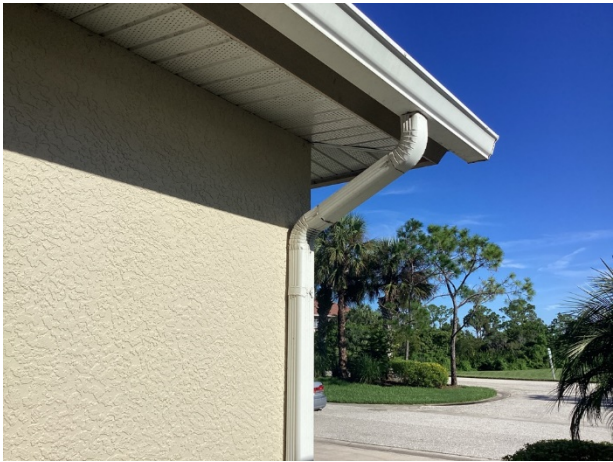
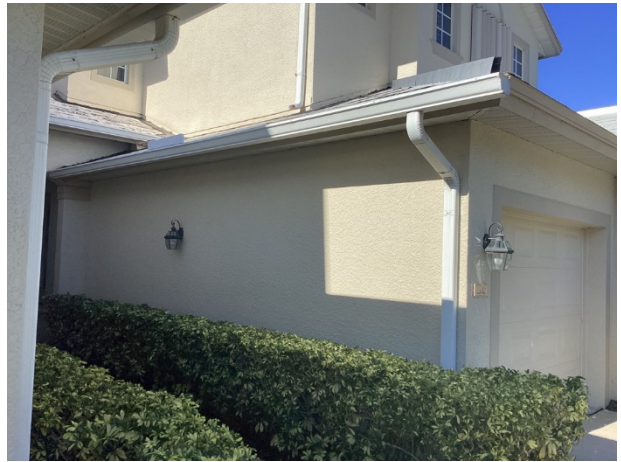
Condition: Good to fair overall with isolated leakage at seams and dented sections evident.

Aluminum gutters and downspouts

- Semi-annually:
 - Clean out debris and leaves that collect in the gutters
 - Repair and refasten any loose gutter fasteners
 - Repair and seal any leaking seams or end caps
 - Verify downspouts discharge away from foundations

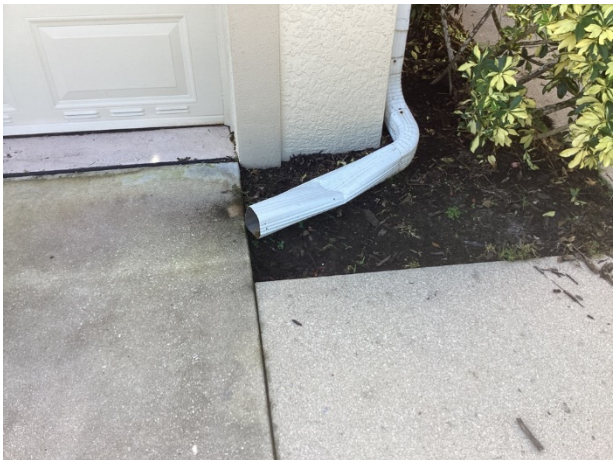
Dented downspout

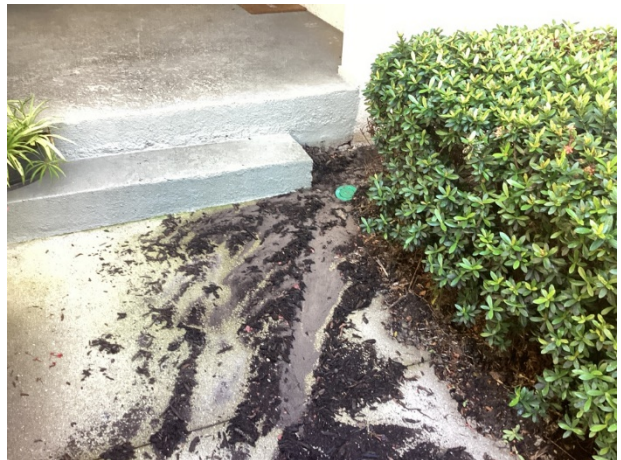
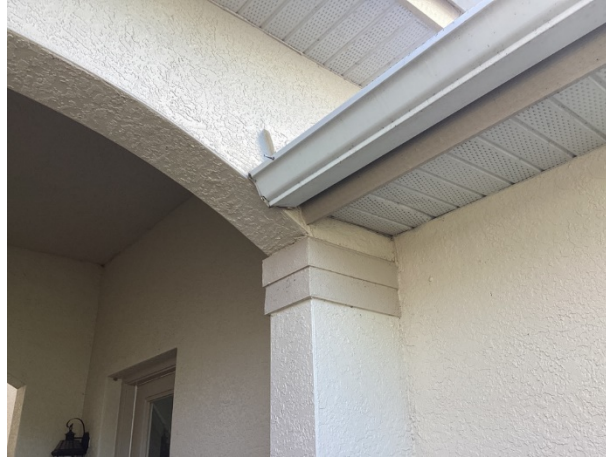
Building 4628 unit 202 – gutter leak

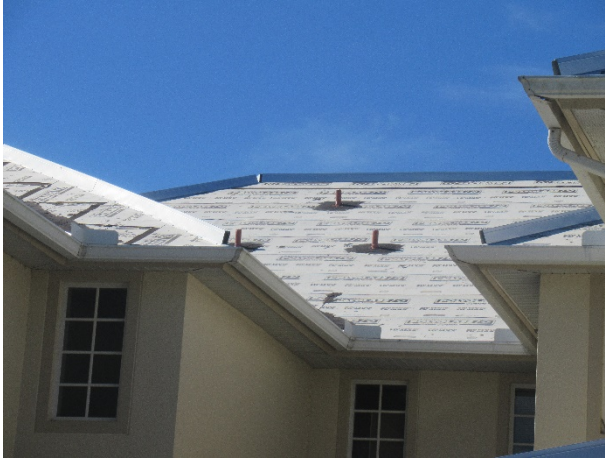
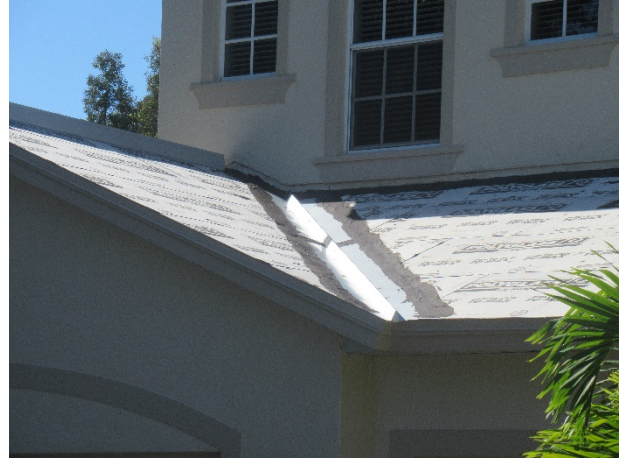
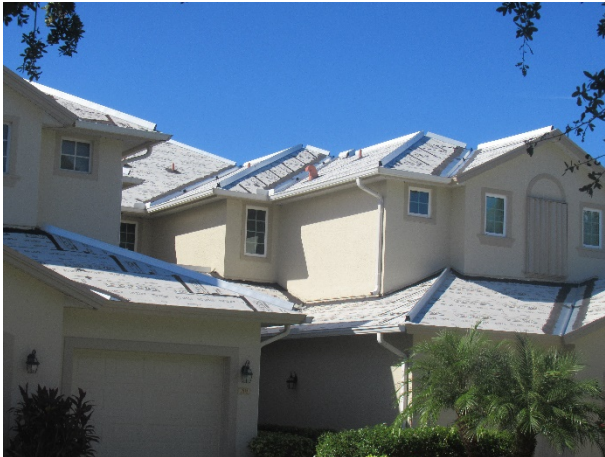
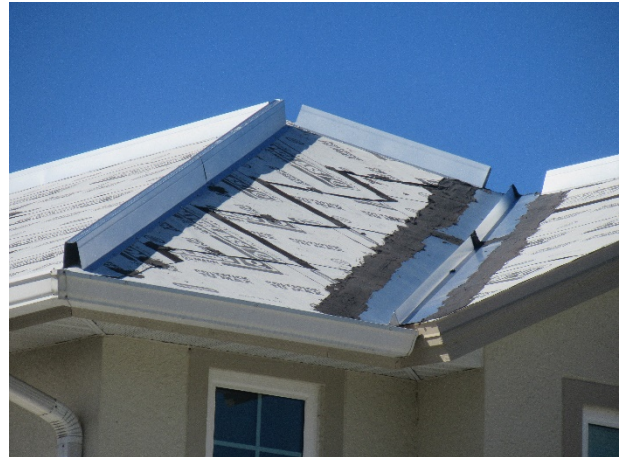
Condition: Good overall

Roof overview

- Annually:
 - Record any areas of water infiltration, flashing deterioration, damage or loose tiles
 - Implement repairs as needed if issues are reoccurring
 - Ensure proper ventilation and verify vents are clear of debris and not blocked from attic insulation
 - Trim tree branches that are near or in contact with roof
 - Periodic cleaning at areas with organic growth

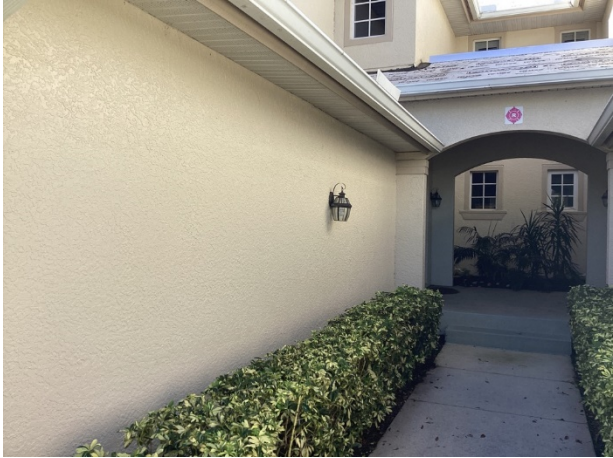
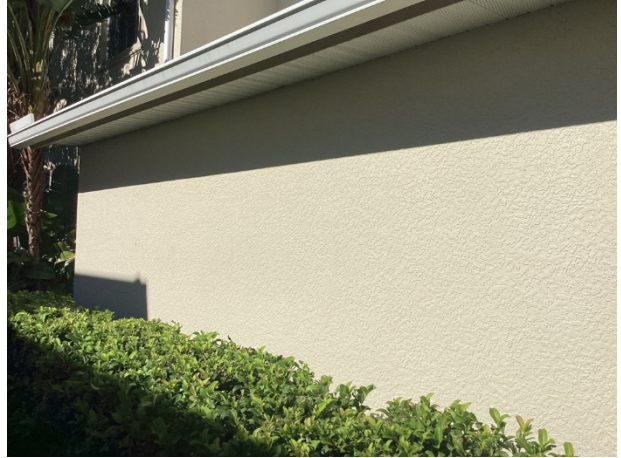
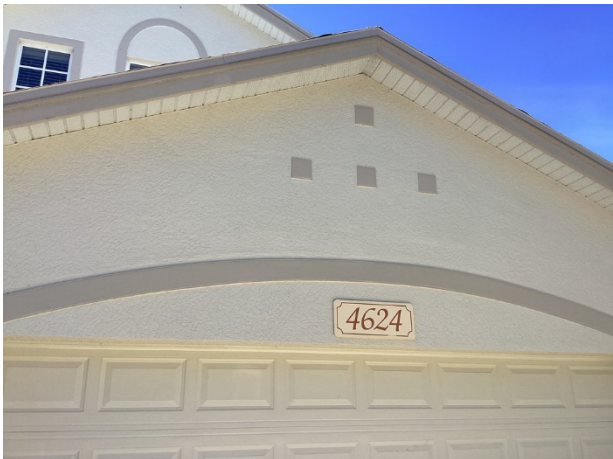
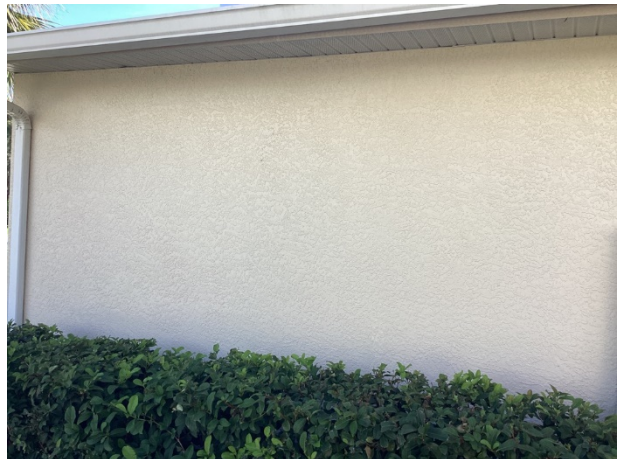
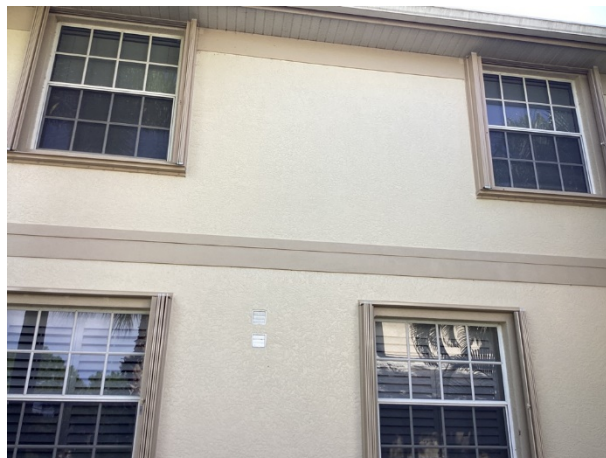
Condition: Good overall

Stucco wall finishes

Useful Life: We recommend inspections, repairs and paint finish applications every five- to seven-years. At the request of Management and the Board, we have included pressure washing of the exterior walls every two years.

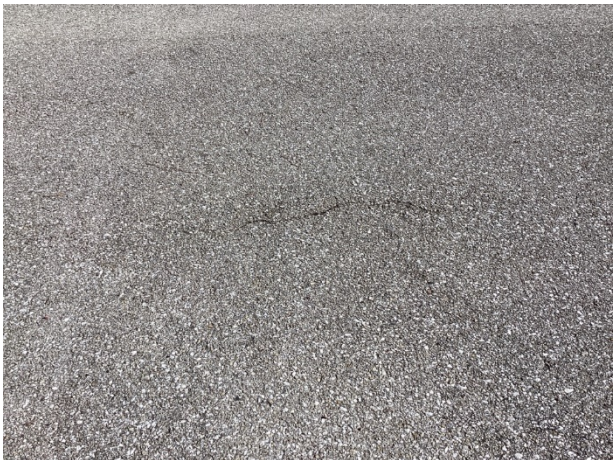
Condition: Good to fair overall with isolated cracks evident

Pavement cracks

- Annually:
 - Inspect for settlement, large cracks and trip hazards, and ensure proper drainage
 - Repair areas which could cause vehicular damage such as potholes

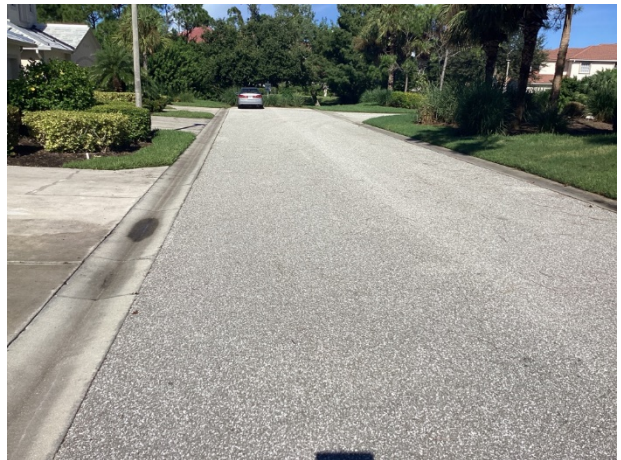
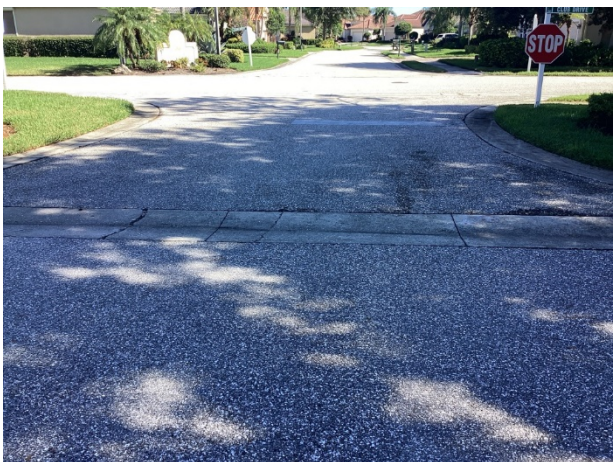
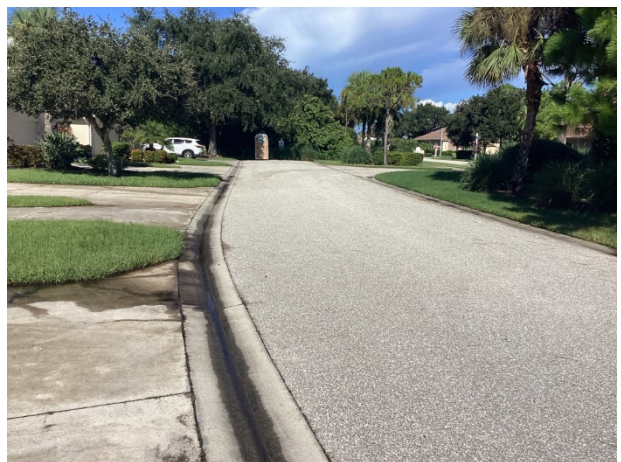
Asphalt pavement parking lot overview

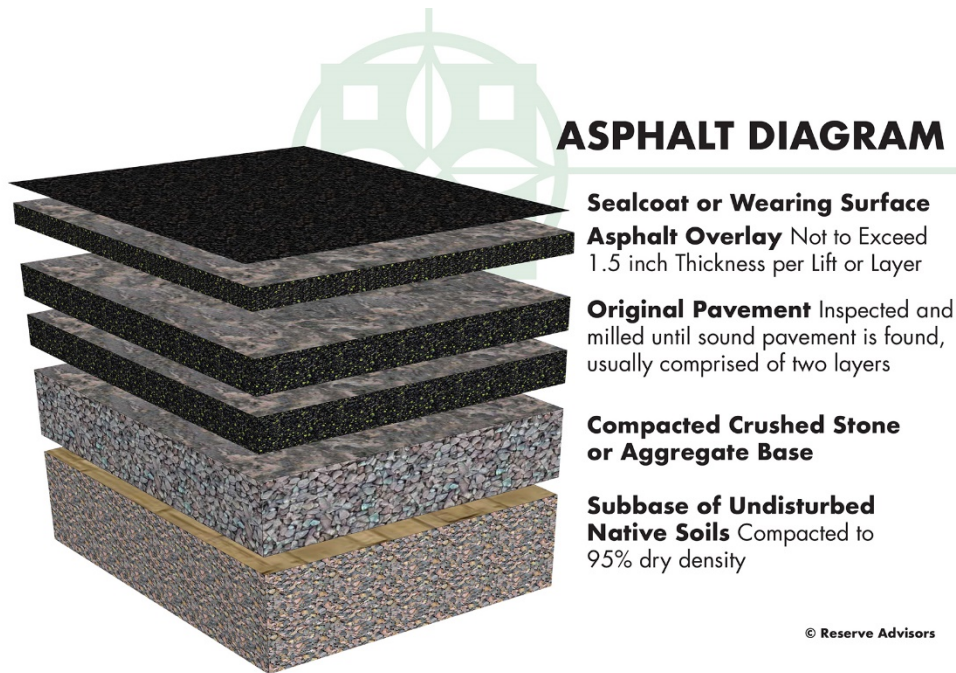
Component Detail Notes: The initial installation of asphalt uses at least two lifts, or two separate applications of asphalt, over the base course. The first lift is the binder course. The second lift is the wearing course. The wearing course comprises a finer aggregate for a smoother more watertight finish. The following diagram depicts the typical components although it may not reflect the actual configuration at Tarpon Harbor at Myakka Pointe:

The manner of repaving is either a mill and overlay or total replacement. A mill and overlay is a method of repaving where cracked, worn and failed pavement is mechanically removed or milled until sound pavement is found. A new layer of asphalt is overlaid atop the remaining base course of pavement. Total replacement includes the removal of all existing asphalt down to the base course of aggregate and native soil followed by the application of two or more new lifts of asphalt. We recommend mill and overlayment on asphalt pavement that exhibits normal deterioration and wear. We recommend total replacement of asphalt pavement that exhibits severe deterioration, inadequate drainage, pavement that has been overlaid multiple times in the past or where the configuration makes overlayment not possible. Based on the apparent visual condition and configuration of the asphalt pavement, we recommend the mill and overlayment at Tarpon Harbor at Myakka Pointe.

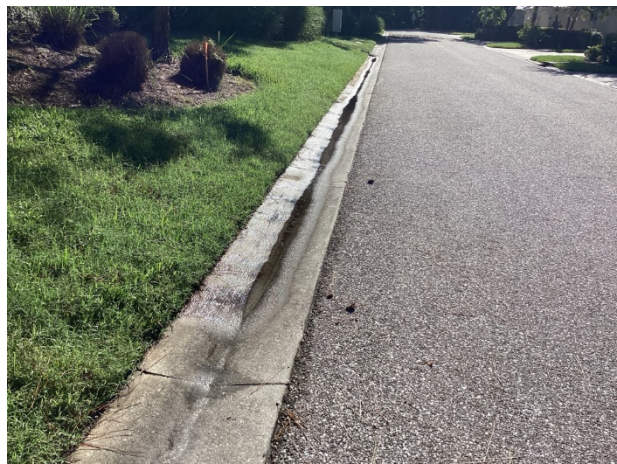
History and Condition: Original; Good to fair overall with isolated cracks and standing water evident

Standing water

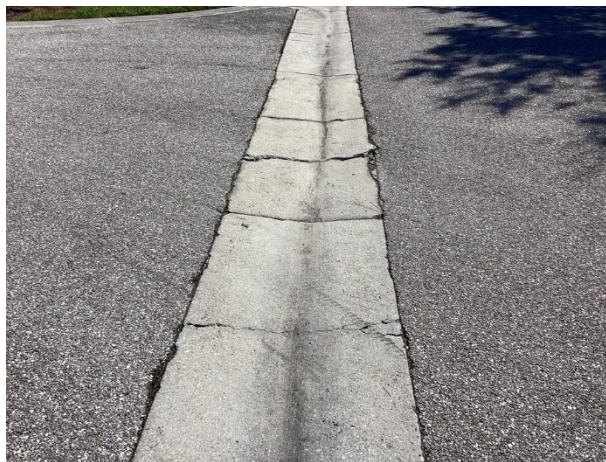
Gutter cracks

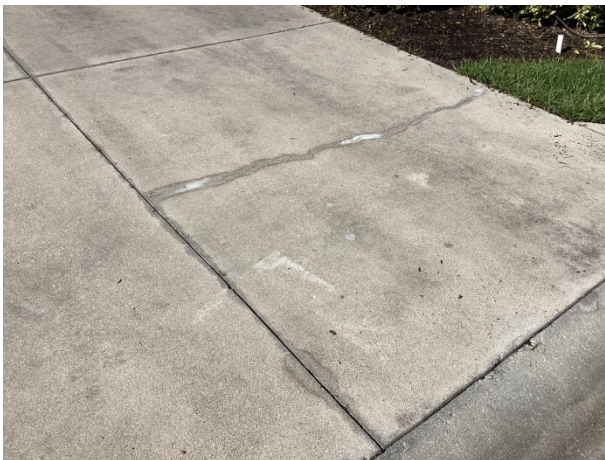
History and Condition: Good to fair overall with isolated cracks evident.

Driveway cracks
